# 3.1 BUILDING TYPOLOGIES ASSESSMENT

## 3.1.2 Typologies Assessment

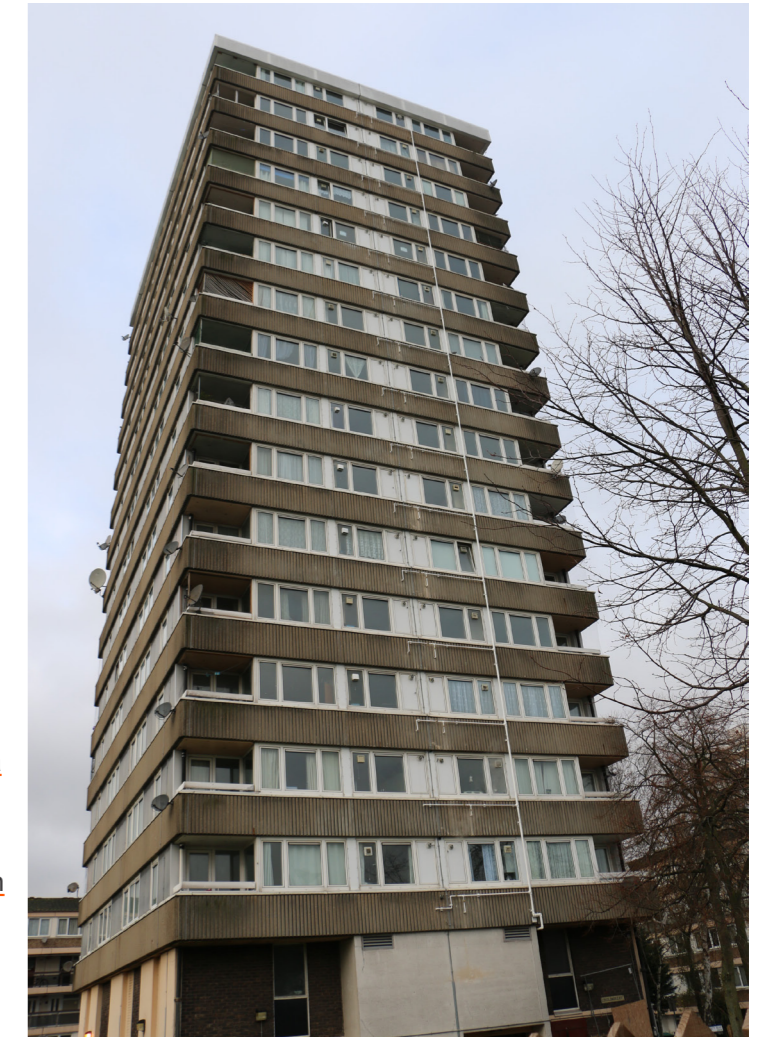
Figure 32  
Tower Block

The intrusive structural survey has confirmed that the exposed reinforced concrete elements of the structure are largely free from any significant defects with very little visible evidence of any concrete having cracked and/or spalled as a consequence of reinforcement corrosion.

Each of the towers has a poor relationship to its context with little or no relationship to surrounding buildings.

The two towers identified as having the best potential for retention and integration are Madingley and Brinkley which are sited furthest north and closest to Cambridge Road. Graverley is surrounded by podium areas and would be difficult to integrate into a new development and Childerley constrains the potential for development of this part of the site given its shape and surroundings.

The flats could potentially be refurbished as noted in section 3.2 with some reconfiguration and the addition of new balconies external to the building footprint.

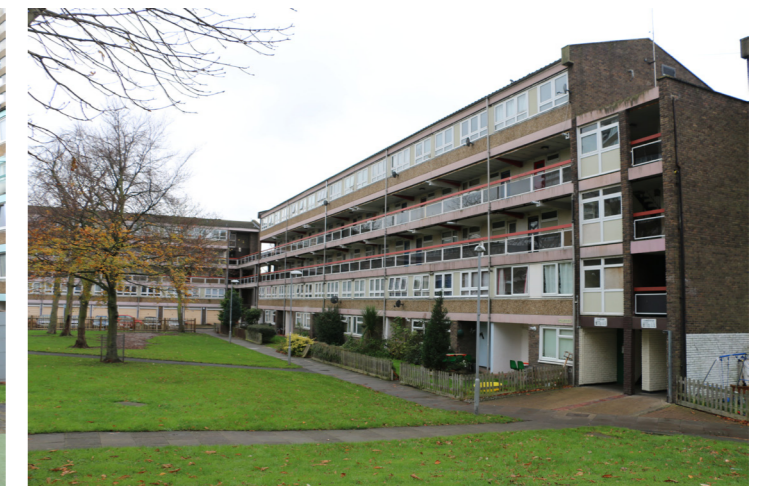
Figure 33  
Mid-rise Blocks

The intrusive structural survey has confirmed that the exposed reinforced concrete elements of the structure are largely free from any significant defects with very little visible evidence of any concrete having cracked and/or spalled as a consequence of reinforcement corrosion. With the exception of the precast aggregate panels, the exposed surfaces have been treated with what is believed to be masonry paint which has begun to erode and in a few places it has begun to blister and de-bond otherwise the buildings are structurally sound.
